# Programming the CCS charging port

Designwerk Technologies AG

The update described in these instructions applies to the CCS charging port V3.0. How a CCS charging port V3.0 can be recognized is described on the next two pages.

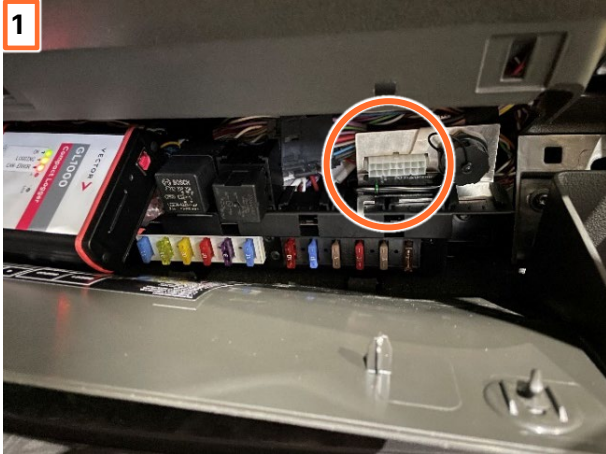
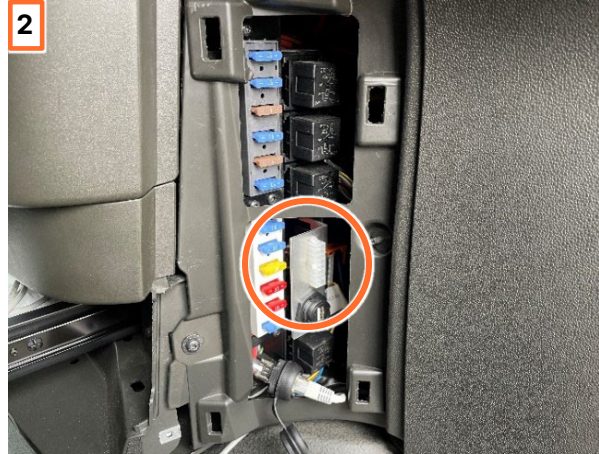
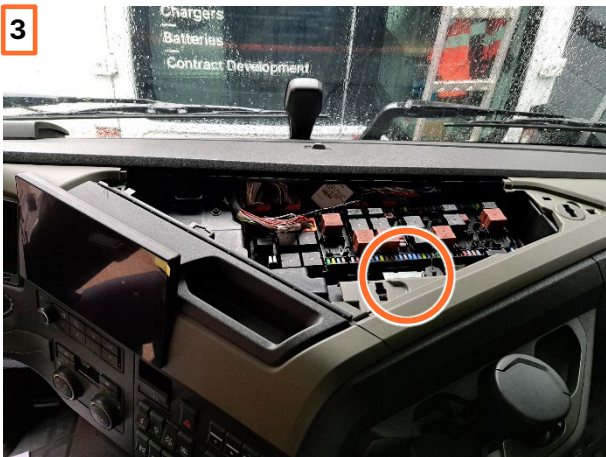
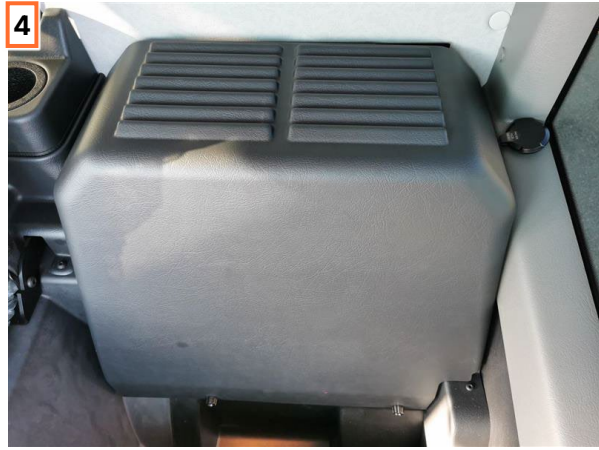
## 5.4 Position of the CAN interfaces according to vehicle type and connections

| 1 | Mid Cab V2.1 passenger footwell | 2 | High Cab center console |
| 3 | Mid Cab V2.2 center console | 4 | Low cab E-compartment |

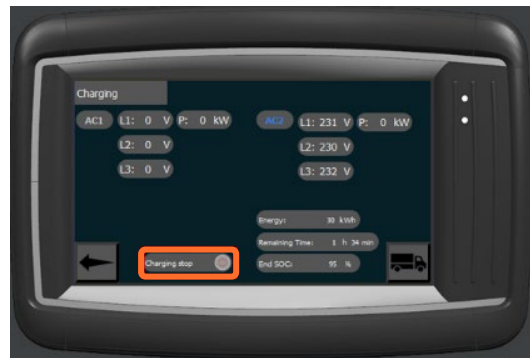
- 5 Press the charging stop button 8 times in succession at intervals of one second. This switches the CCS charge controller to programming mode.

HMI V1 E-LKW 2.2 HMI V0 E-LKW V2.1
