## Repair instruction

# Exchanging PTO A

Designwerk Technologies AG

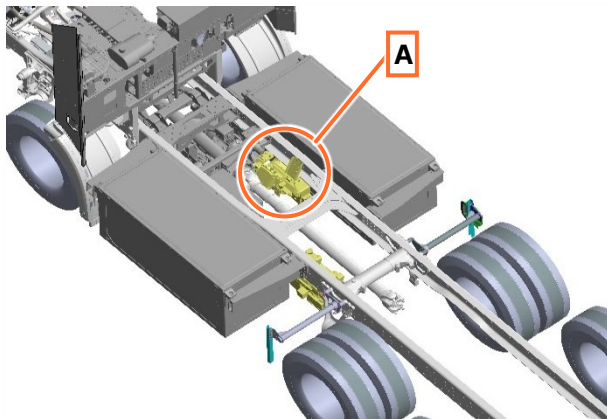
A – The PTO A is installed in the chassis to the right of the AUX module for all wheelbases.

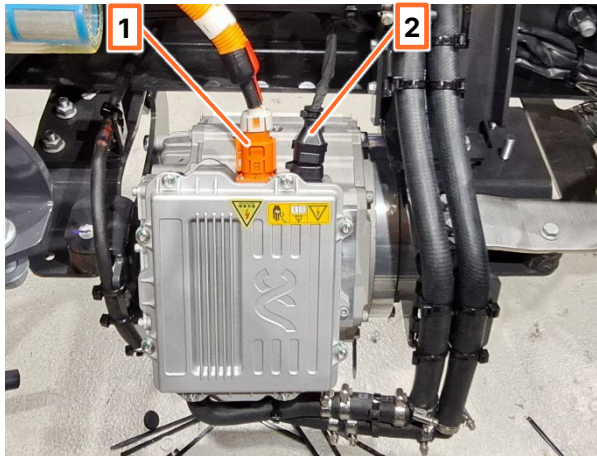
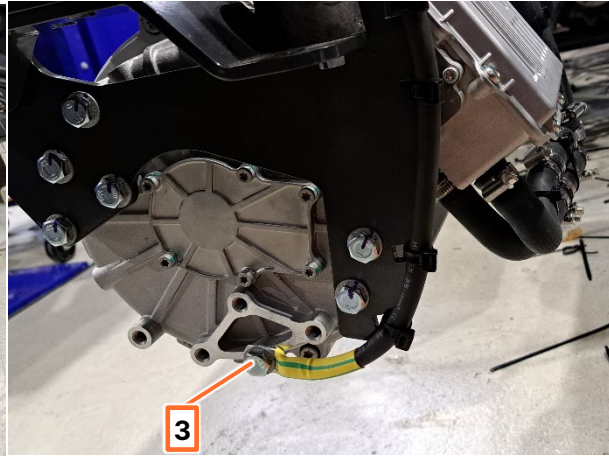
| 1 | HV-cable | 3 | Potential equalisation cable |
| 2 | LV-cable | | |

#### **2 Disconnect the HV-cable (1)**

- For this purpose, unplug the plug at the PTO.

#### **3 Disconnect the LV-cable (2)**

#### **4 Disconnect the potential equalisation cable at the PTO-motor (3)**

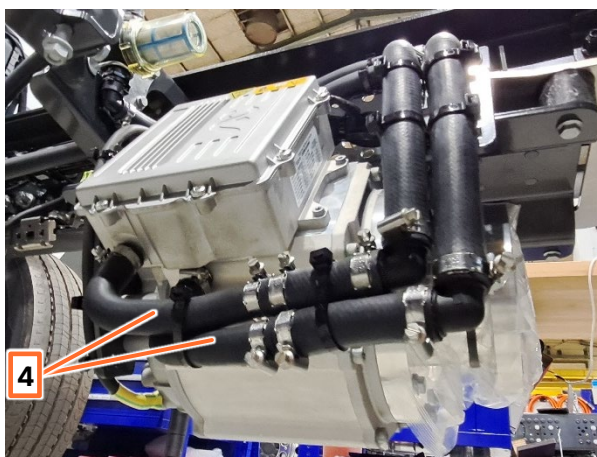
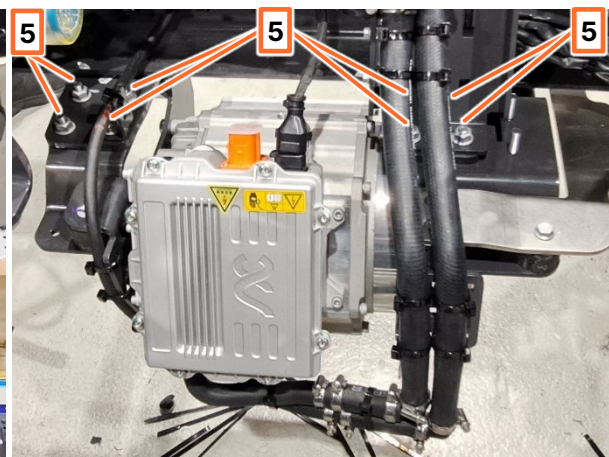
| 4 | Coolant lines | 5 | Nuts on holder |

#### **6 Unplug the coolant lines (4)**

- Disconnect the two coolant lines (4) and unplug them at the motor.

#### **7 Loosen the nuts (5)**

Torque: 37 Nm
